### FIVE YEAR REVIEW SOURCE CONTROL REMEDY

## PICILLO FARM SUPERFUND SITE COVENTRY, RHODE ISLAND

MAY 1993

U.S. ENVIRONMENTAL PROTECTION AGENCY REGION I

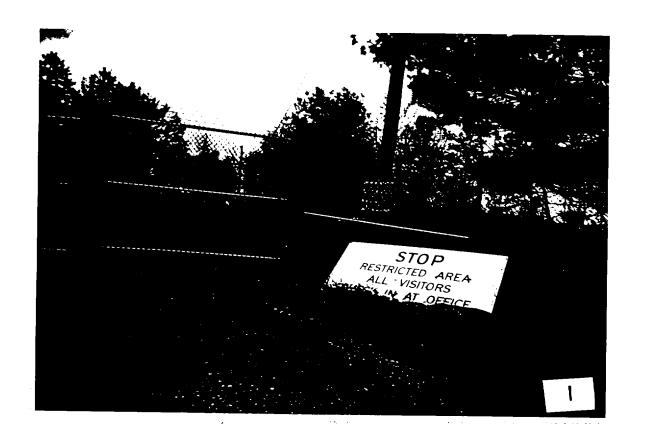
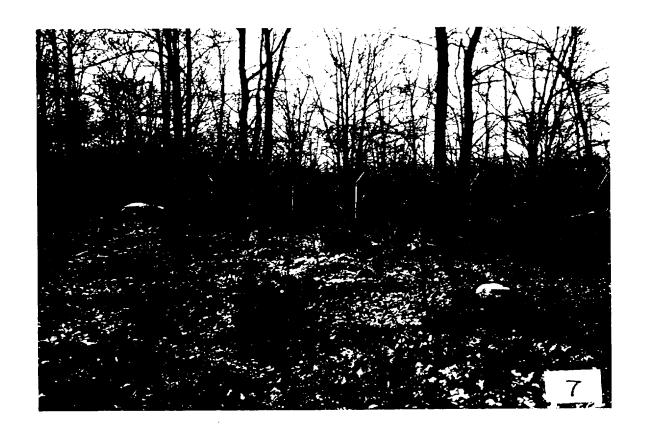
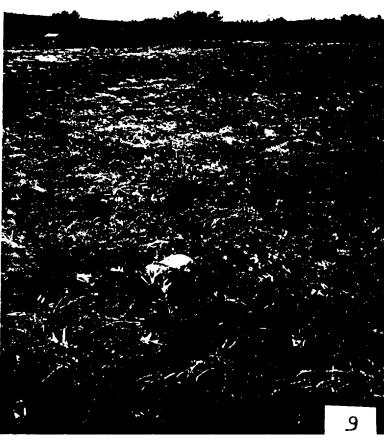
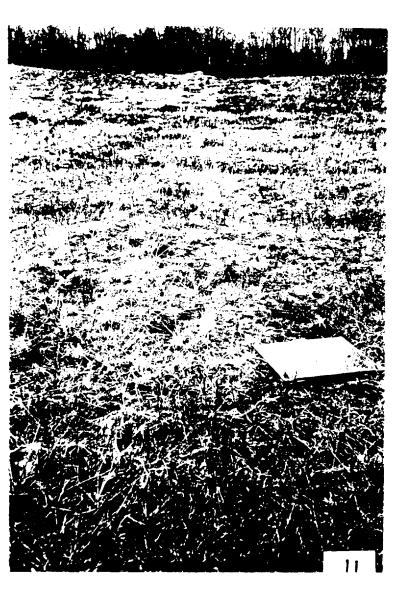
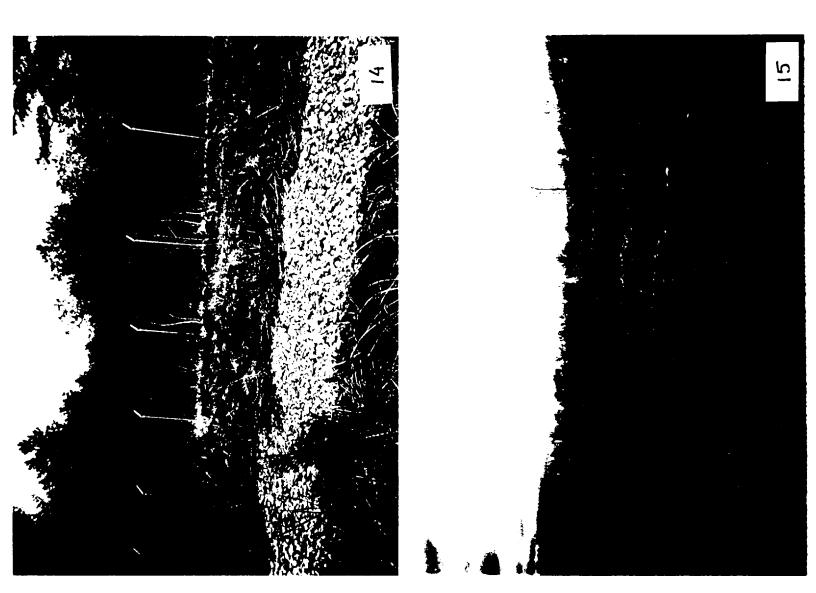
## Photographs April 27, 1993 Site Visit - Picillo Farm Superfund Site

- O The Site was found to be fenced with gates locked.
- No significant erosion was observed on graded areas within the fence.
- An adequate amount of vegetation cover was observed within the fence with the exception of the area of the former "PCB pile". The area is still protected by the haybales staked by the perimeter of the former "PCB pile".
- Rock and grass drainage ditches were found in good condition and are functioning as designed.

- Several areas with sparse vegetation and moss were observed in the west and north areas of the Site.
- Small holes, 1-2 inch deep, apparently caused by small animals, were observed throughout the enclosed area.

- Multiple areas along the fence were sufficiently off the ground (4-6 inches) to allow access by small animals.
- Monitoring wells observed during the visit were capped and locked.

- O Thirteen drums were observed in the former truck decontamination area. Ten drums marked "SB Soil" are used to temporary store the soil from soil borings performed in the Summer of 1991 as part of the Remedial Investigation. Three drums with no covers were empty. In addition, two more empty drums are used to mark the access road in the northeast corner of the Site. The ten drums containing SB soil will be removed from the site and disposed of.

Photograph Number	Description
1	Northeast Gate
2	Decontamination/Drum Staging Area
3	Access Road Along East Side of the Fence
4	Former Northeast Trench
5	Former PCB pile
6	Southeast Gate
7	South Side of the Fence
8	Southwest Gate
9	View of Central Portion of the Site
10	Drainage Ditch from the Former PCB Pile
11	Sparse Vegetation with Moss, West Trench
12	Tanker and Drums with Well Development Water
13	Northwest Trench Drainage Ditch
14	North Fence and Drainage Ditch
15	View of North Portion of the Side, Example of Sparse Vegetation.

- Periodic site inspections should continue.
- No additional work on the drainage structures, grading or vegetation cover is necessary or warranted at this time.
- No work on the fence, gates or fence locking mechanisms is necessary or warranted at this time.
